**FOREST LAKE DAM**

**NDI ID NO. PA-00968**

**PHASE I INSPECTION REPORT  
NATIONAL DAM INSPECTION PROGRAM**

**MAY 1981**

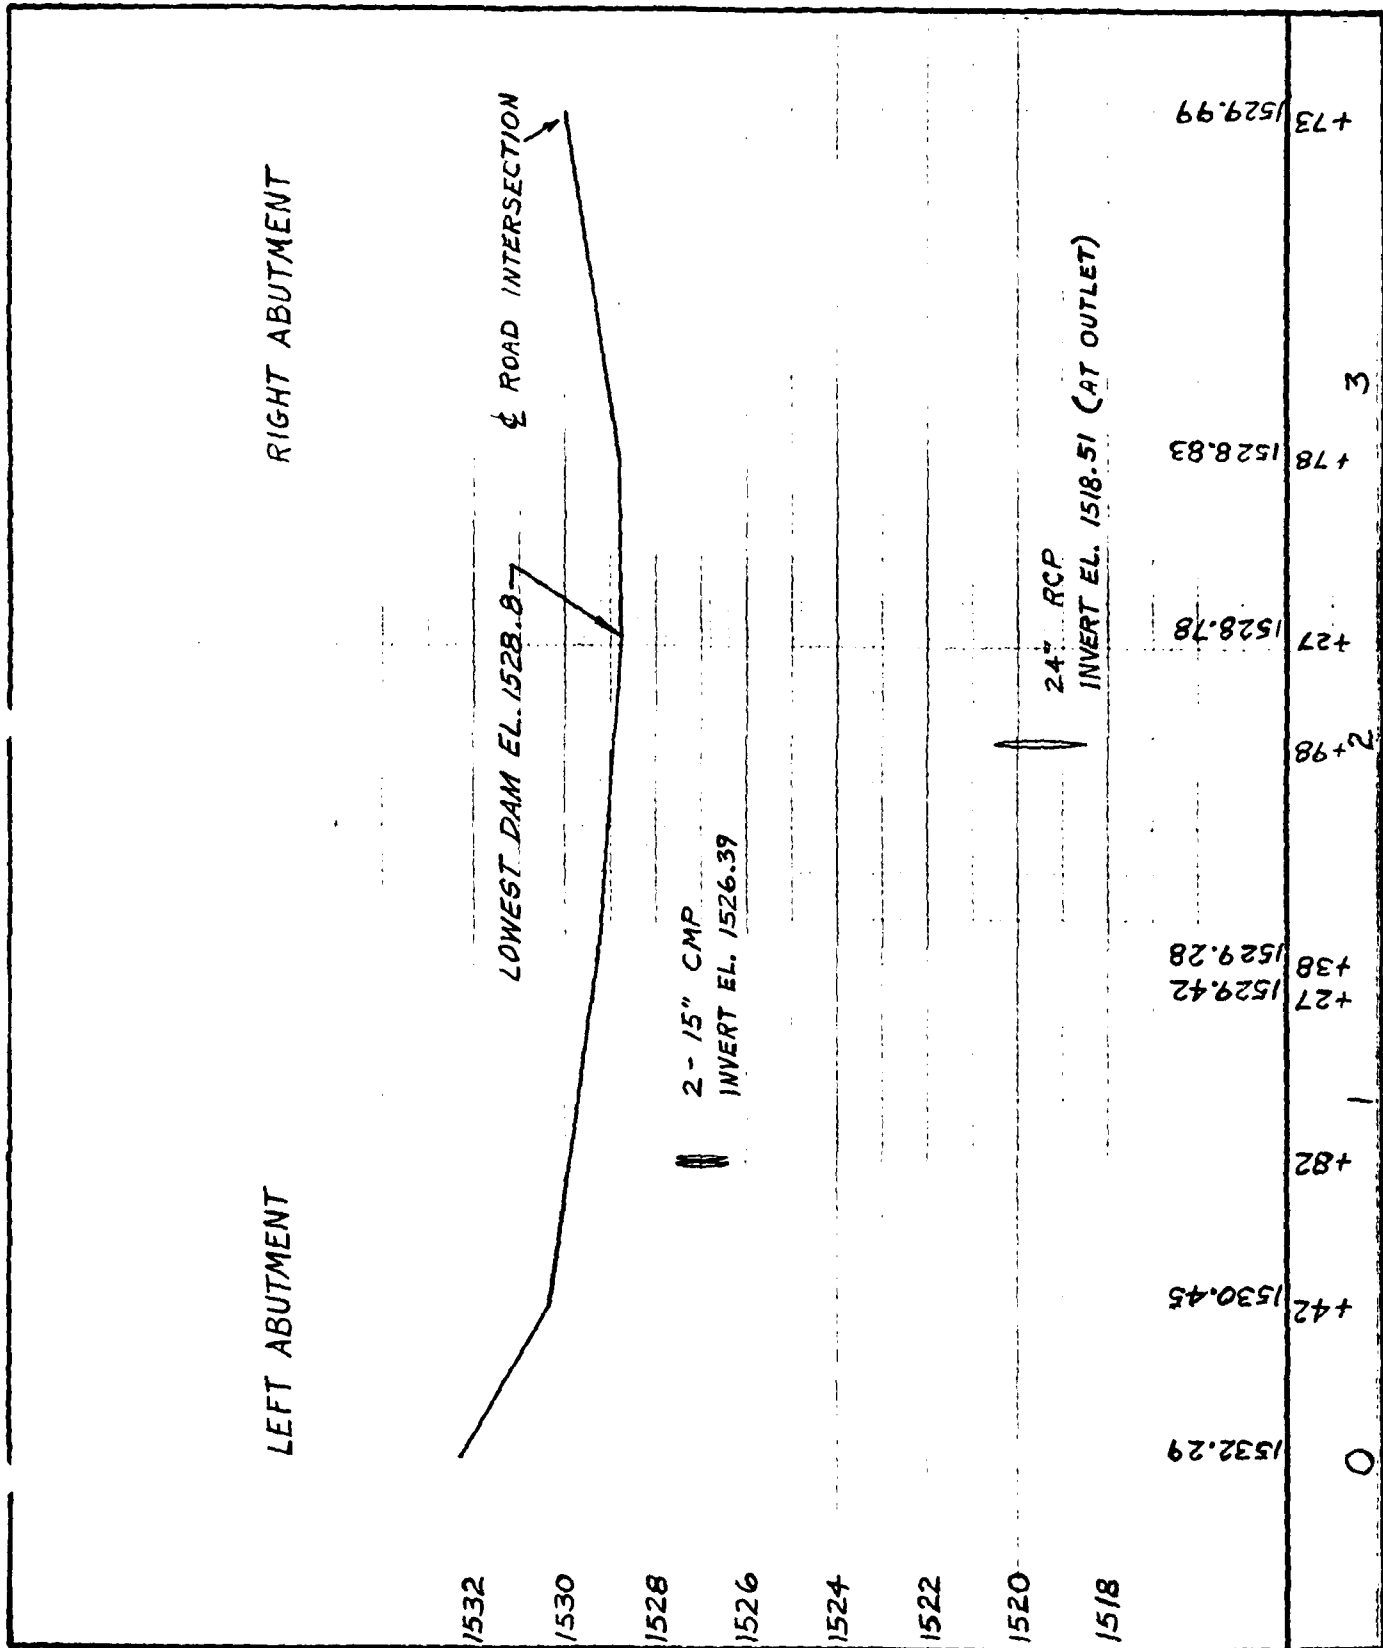
a. General. The overall appearance of the dam is poor. Location of observed deficiencies are shown on the General Plan, presented in Exhibit A-1, Appendix A. The profile and typical sections of the dam are presented in Exhibits A-2, A-3 and A-4 and are based on field survey made on the day of inspection. The survey datum for this inspection is elevation 1527 feet above mean sea level which is stamped on the USGS Bench Mark (No. TT15K, 1931) on the large sandstone slab, upstream of the service spillway. On the inspection date (12/10/1980), the lake was being drawn down for the winter. The lake level was approximately at elevation 1523.6, or 2.8 feet below its normal level. Deficiencies observed during the field inspection are described below and further illustrated in Exhibit A-1, Appendix A. Visible features are depicted in photographs presented in Appendix C.

b. Dam. Observations made during inspection indicate that the dam is in poor condition. The upstream slope varies, having a vertical concrete wall along a distance of 19 feet in the vicinity of the outlet works (see Outlet Works, Exhibit A-4). The remaining upstream face is unprotected earthfill embankment with the steepest slope being 1V to 1.43H (see Exhibits A-3, A-4 and photographs 1 and 2, Appendix C). The top width of the dam varies from 14-feet at the left abutment to 30 feet at the outlet works. The lowest top of dam elevation is 1528.8 and is located near the right abutment (see top of dam profile, Exhibit A-2). Lake Hill Road (TR 643) traverses the crest of the dam, rising in elevation at each abutment (see Exhibits A-1 and A-2). The downstream face of the dam includes a 20-foot long, near-vertical dry masonry wall, rising from the downstream toe of the dam near the left abutment, to an approximate elevation 1526 (see Section A, Exhibit A-3 and Photographs 3 and 4, Appendix C). The top left end of the stone wall is characterized by overhanging stones, up to 12-inches off the vertical face and is subjected to a surcharge from the upstream earthfill section. The balance of the stone wall had collapsed (see Photographs 3 and 5, Appendix C) within the limits shown in Exhibit A-1. Between the outlet works and the right abutment, the downstream face of the dam is an earth embankment, varying in slope from 1V:1.34H at the outlet works (see Exhibit A-4) to 1V:1.5H at the right abutment. Approximately 3 Gallons Per Minute (GPM) seepage was observed to emanate from the toe of the dam between the collapsed stone wall and the outlet works. There was no evidence of piping at the toe of the dam on the day of the inspection. Growth of trees within the dam proper is limited to a 24-inch diameter ash on the downstream slope, near the right abutment, and two 16-inch diameter trees near the toe at the left abutment (see Exhibit A-1 and Photographs 3 and 4, Appendix C).

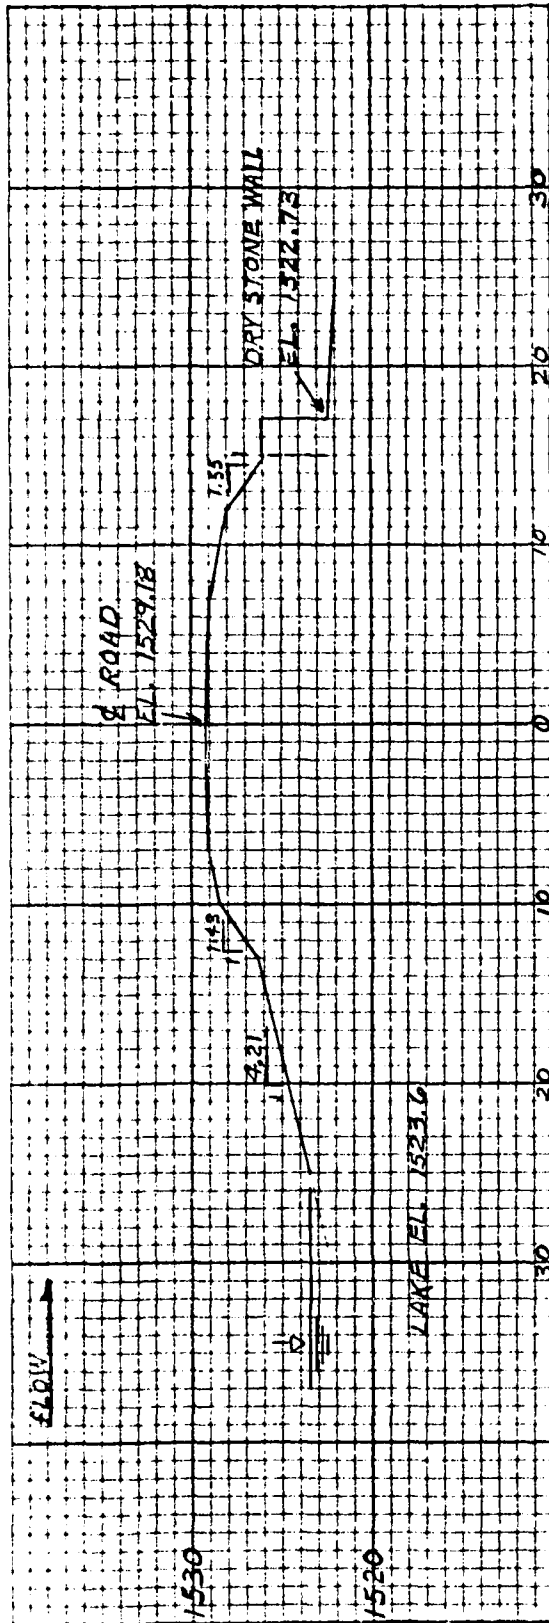
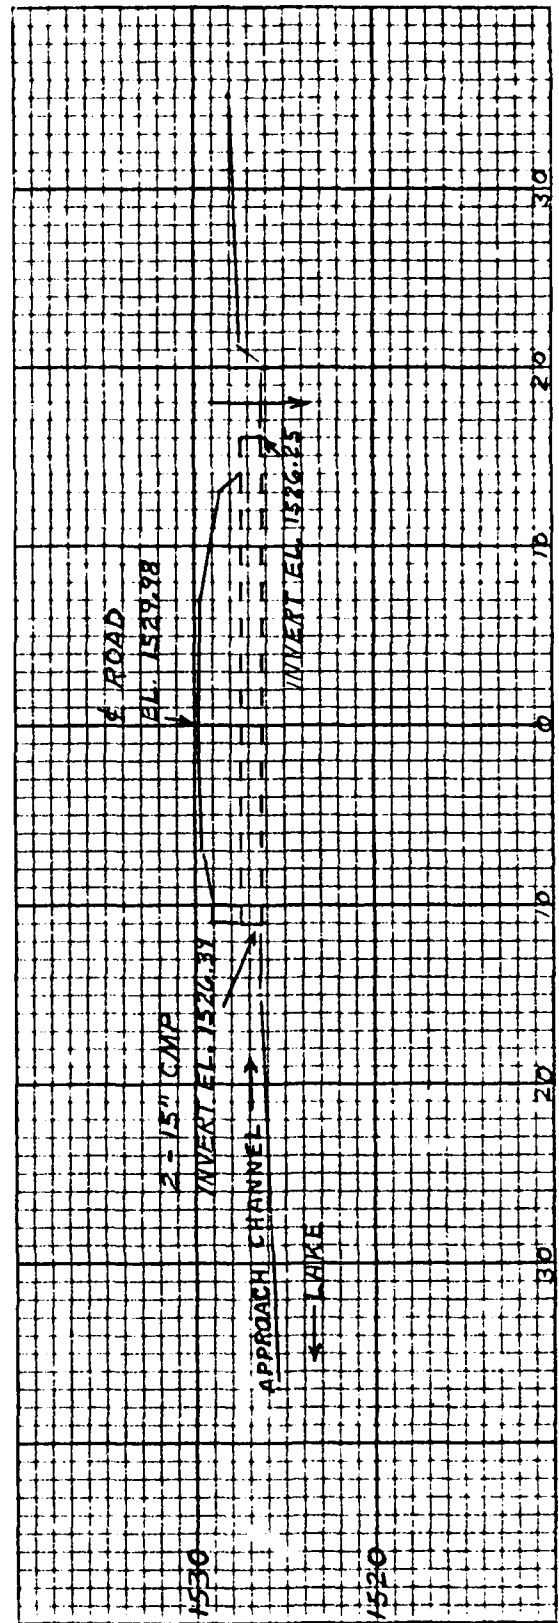
TYPICAL DAM SECTIONS

The outlet works is located near the maximum section of the dam, approximately 80 feet east of the right abutment. On the day of the inspection, the water surface in the reservoir was above the intake and its condition could not be verified. Available data indicates the existence of a trash rack at the inlet to the 24-inch diameter concrete pipe. The slide gate is operable by means of a stem, located near the middle of the concrete headwall (see Exhibits A-1 and A-4).

The top of wall elevation at the right end of the upstream headwall is 0.2 foot higher than that at the left end and the entire top 2-foot section is tilted upstream by approximately 5 degrees off vertical. The visible portion of this wall has a 4V to 1H batter on the back side. On the day of the inspection, the reservoir was being lowered for the winter and the flow through the 24-inch diameter concrete pipe was approximately 200 GPM, creating a free overfall into the outlet channel. The outlet of the concrete pipe appears to be in good condition. The outlet channel extends to the left of the outlet pipe, joining the natural stream channel approximately 15 feet downstream of the pipe outlet. Immediately downstream of the outlet pipe, the bottom of the channel is eroded to a depth of 18 to 24 inches (see Exhibits A-1, A-4 and Photograph 4, Appendix C).
